# Manhole Inspection Summary

Manhole # S13MM\_007MH

Insp Date: **2/20/09 1:04 PM**

**Location** Address: **ELGIN AVE**

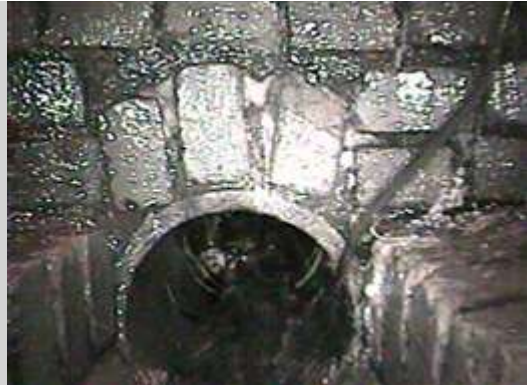
12 O'Clock Outflow

10 in. Circular Gravity Sewer  
Pipe Out @ 12 O'Clock

Pipe Height: **6** (in.) Rod and Bar  
Pipe Material: **Clay** ☐ Pipe Lined  
Invert Depth: **18.76** (ft.) Flow Characteristics: **Fast**  
Deposits: ☒ None ☐ Mud ☐ Sludge ☐ Debris ☐ Grease  
Silt Depth: (in.) Deposits Extent:  
Infiltration: **None** Pipe Seal Cond: **Sound**

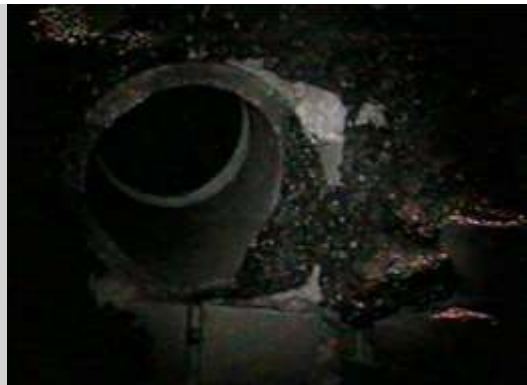
5 O'Clock Inflow

8 in. Circular Gravity Sewer  
Pipe In @ 5 O'Clock

Pipe Height: **3.6** (in.) Rod and Bar  
Pipe Material: **Clay** ☐ Pipe Lined  
Invert Depth: **13.90** (ft.) Flow Characteristics: **Fast**  
Deposits: ☒ None ☐ Mud ☐ Sludge ☐ Debris ☐ Grease  
Silt Depth: (in.) Deposits Extent:  
Infiltration: **None** Pipe Seal Cond: **Sound**

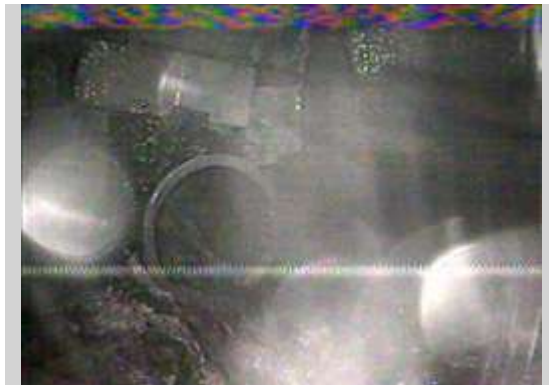
Drop In @ 5 O'Clock

Drop: **Outside Direct**  
Angled: Reading: (ft.)  
Inv Depth: **17.68** (ft.)  
Drop Condition: **Open**

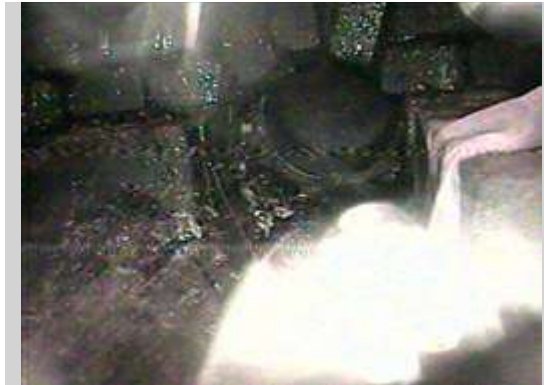
Drop In @ 6 O'Clock

Infiltration: **None** Pipe Seal Cond: **Cracked**

Drop: **Outside** **Direct**

Inv Depth: **18.36** (ft.)

Drop Condition: **Open**

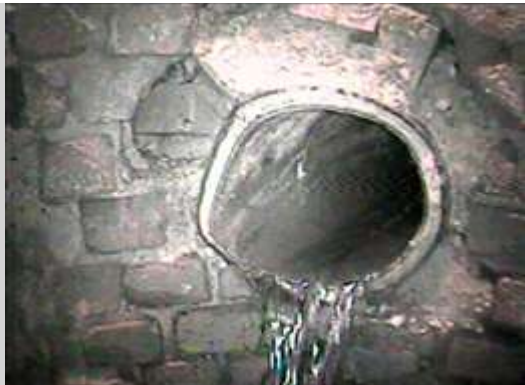
9 O'Clock Inflow

10 in. Circular Gravity Sewer

Pipe Height: **4.8** (in.) Rod and Bar

Infiltration: **None** Pipe Seal Cond: **Sound**

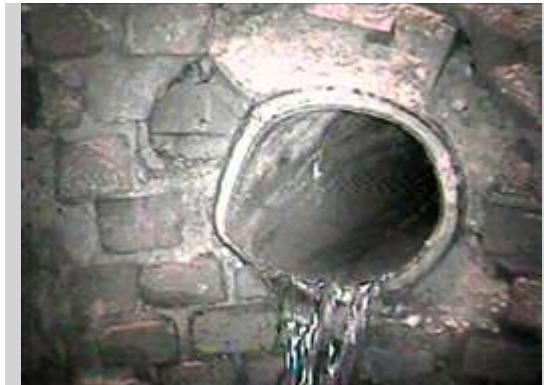
Drop In @ 9 O'Clock

Drop Condition: **Open**
